TEST REPORT

No. : SC100620597

Sample Name : Shoring tower
Sample Number : SC100620597
Test Required : Load capacity
Test Method : SGS in house
Product specification : ST 60
Date of Receipt : Jun. 30, 2014
Test Period : Jun. 30, 2014 to July. 02, 2014
Test result(s) : For further details, please refer to the following page(s)

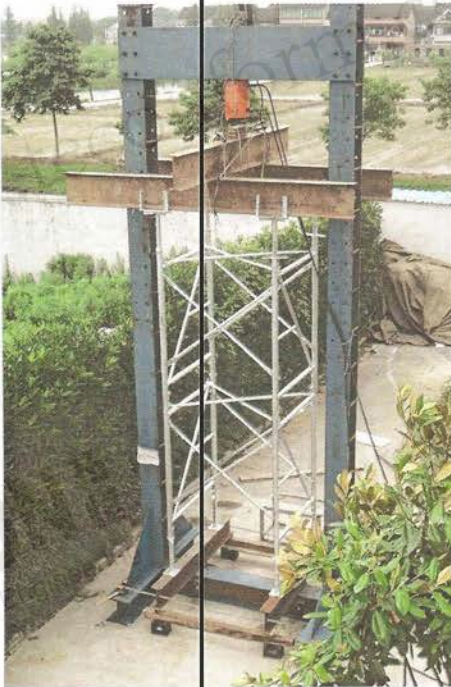
Before test

1. Install the scaffold in accordance with manufacturer's indication.
2. Apply a steadily increasing load to the four support pillars until failure of any part of the scaffold occurs or the load can not be increased availablely.
3. Record the maximum load and the failure status.

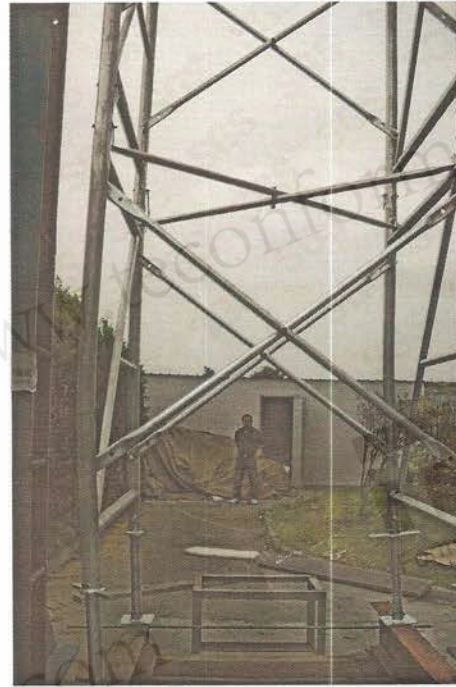
Test item	Test result	Description
Load capacity (four supports total load)	$F_{max} = 857kN$	The support pillar showed permanent distortion.

After test
